Flood Control Project Maintenance
Levee Inspections

Fall 2013 Levee Maintenance Deficiency Summary Report

Sacramento River Basin

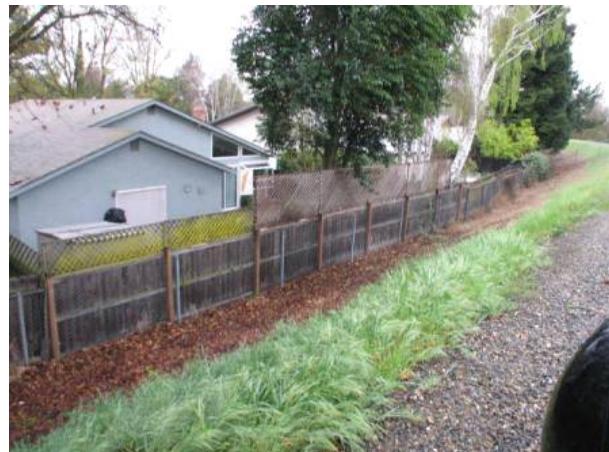
Levee Mile Report Line	207
Start Levee Mile	10.63
End Levee Mile	10.63
Location	Land Side
Category	Earthen Levee
Item	Encroachments
03/16/2012 Wood privacy fence completely obstructs access and visibility.	
mkhashch_f_20130923_005.jpg

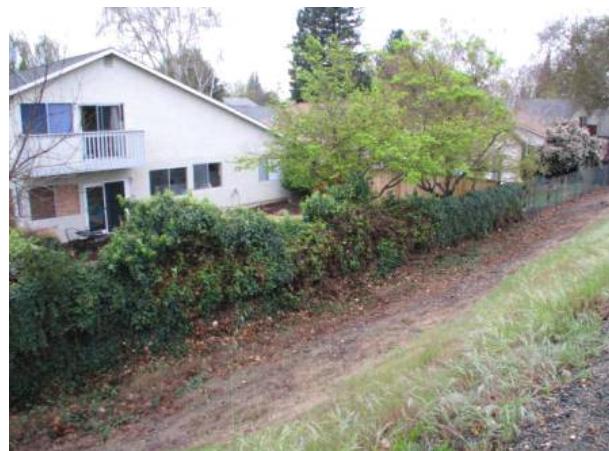
Levee Mile Report Line	208
Start Levee Mile	10.67
End Levee Mile	10.67
Location	Land Side
Category	Earthen Levee
Item	Encroachments
03/16/2012 Wood privacy fence completely obstructs access and visibility.	
mkhashch_f_20130923_006.jpg

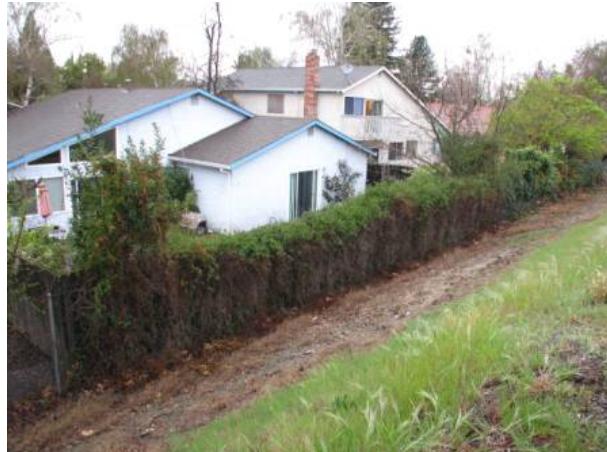
Levee Mile Report Line	209
Start Levee Mile	10.68
End Levee Mile	10.68
Location	Land Side
Category	Earthen Levee
Item	Encroachments
03/16/2012 Wood privacy fence completely obstructs access and visibility.	
mhashch_f_20130923_007.jpg

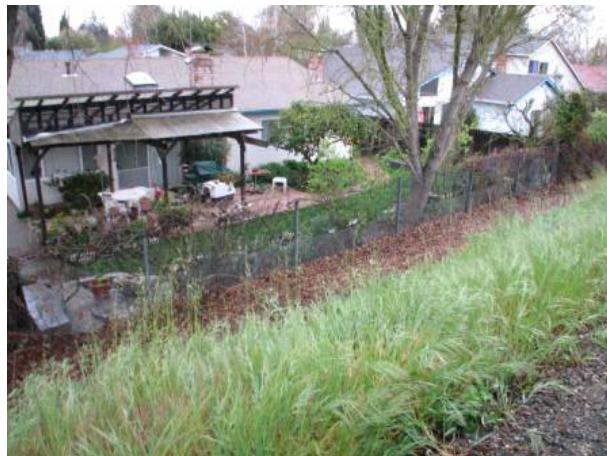
Levee Mile Report Line	210
Start Levee Mile	10.69
End Levee Mile	10.69
Location	Land Side
Category	Earthen Levee
Item	Vegetation
03/16/2012 Trees and bushes within 10' of levee toe.	
mhashch_f_20130923_008.jpg

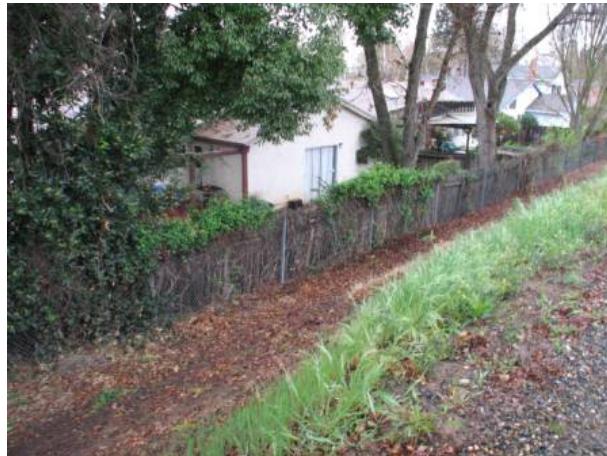
Levee Mile Report Line	211
Start Levee Mile	10.71
End Levee Mile	10.71
Location	Land Side
Category	Earthen Levee
Item	Encroachments
03/16/2012 Wood privacy fence completely obstructs access and visibility.	
mhashch_f_20130923_009.jpg

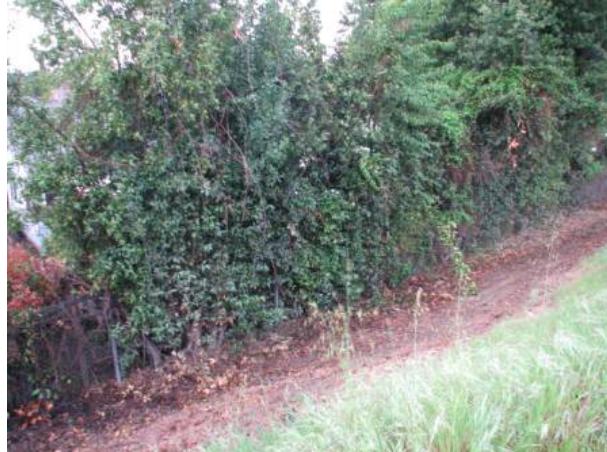
Levee Mile Report Line	212
Start Levee Mile	10.71
End Levee Mile	10.71
Location	Land Side
Category	Earthen Levee
Item	Vegetation
03/16/2012 Landscaping obstructs visibility	
mkhashch_f_20130923_010.jpg

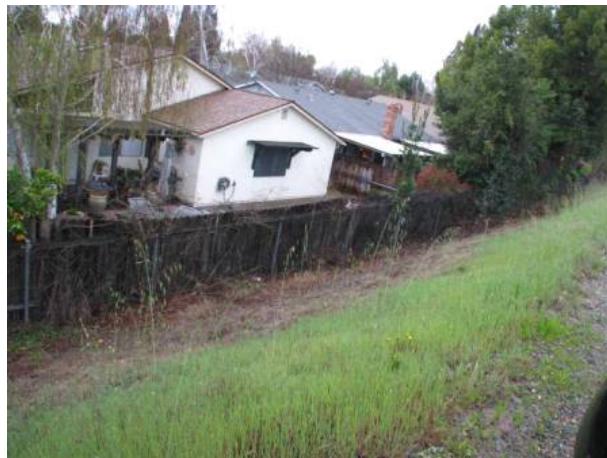
Levee Mile Report Line	213
Start Levee Mile	10.73
End Levee Mile	10.73
Location	Land Side
Category	Earthen Levee
Item	Encroachments
03/16/2012 Wood privacy fence completely obstructs access and visibility.	
mkhashch_f_20130923_011.jpg

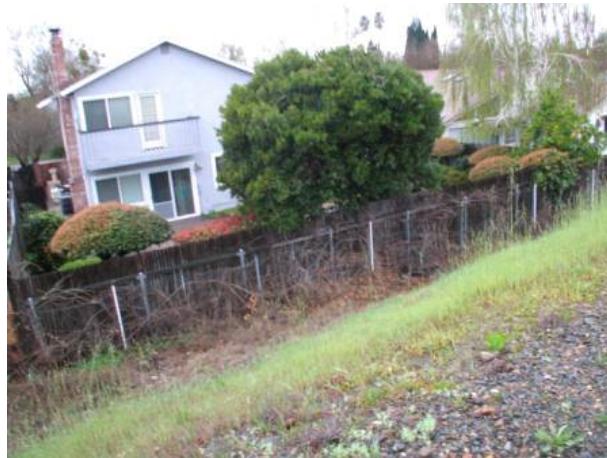
Levee Mile Report Line	214
Start Levee Mile	10.73
End Levee Mile	10.73
Location	Land Side
Category	Earthen Levee
Item	Encroachments
03/16/2012 Wood privacy fence completely obstructs access and visibility.	
mkhashch_f_20130923_012.jpg

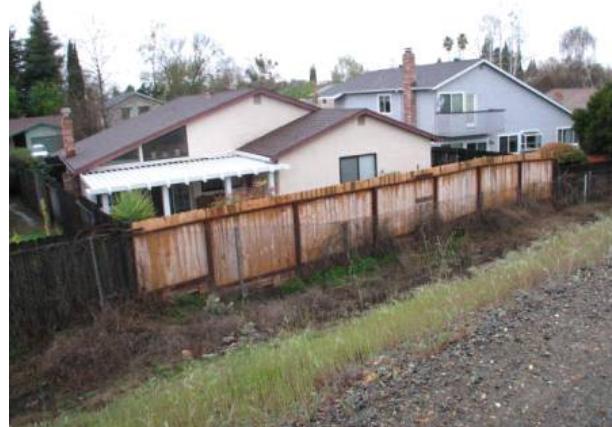
Levee Mile Report Line	216
Start Levee Mile	10.74
End Levee Mile	10.74
Location	Land Side
Category	Earthen Levee
Item	Encroachments
03/16/2012 Wood privacy fence completely obstructs access and visibility.	
mkhashch_f_20130923_013.jpg

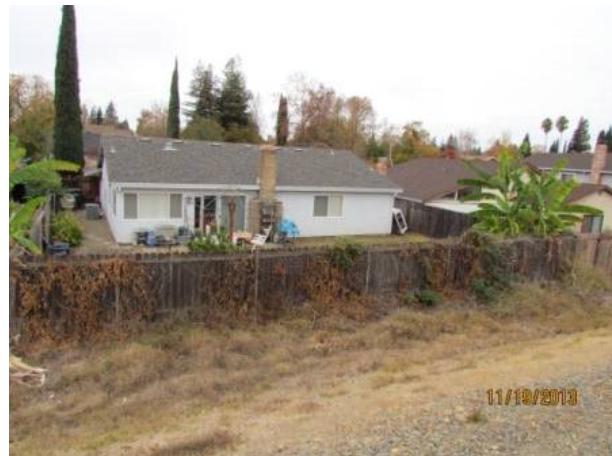
Levee Mile Report Line	217
Start Levee Mile	10.75
End Levee Mile	10.75
Location	Land Side
Category	Earthen Levee
Item	Encroachments
View of wood privacy fence completely obstructing access and visibility.	
mkhashch_f_20131120_721.JPG

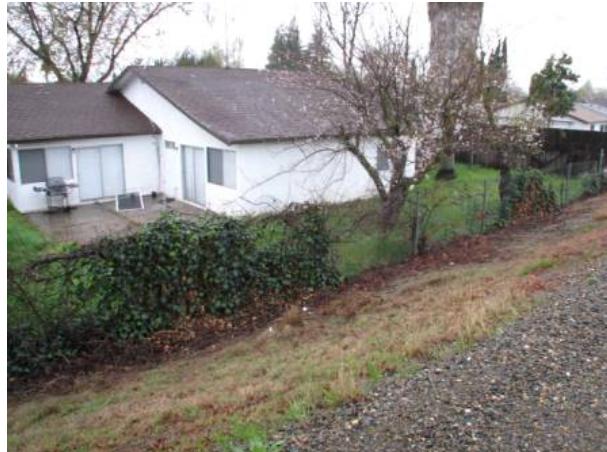
Levee Mile Report Line	219
Start Levee Mile	10.79
End Levee Mile	10.79
Location	Land Side
Category	Earthen Levee
Item	Encroachments
03/16/2012 Chainlink fence partially blocks visibility.	
mhashch_f_20130923_030.jpg

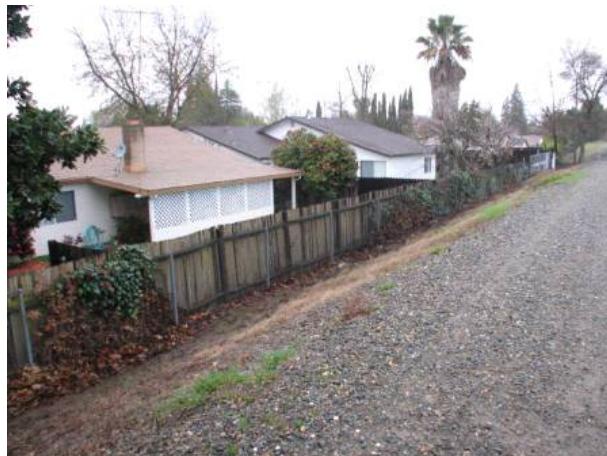
Levee Mile Report Line	220
Start Levee Mile	10.80
End Levee Mile	10.80
Location	Land Side
Category	Earthen Levee
Item	Encroachments
03/16/2012 Wood privacy fence completely obstructs access and visibility.	
mhashch_f_20130923_015.jpg

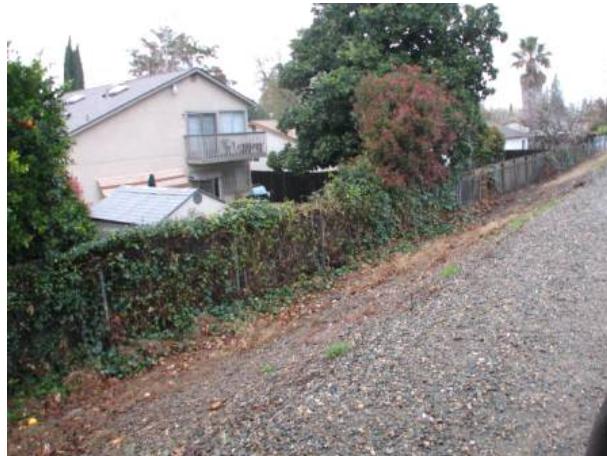
Levee Mile Report Line	221
Start Levee Mile	10.82
End Levee Mile	10.82
Location	Land Side
Category	Earthen Levee
Item	Encroachments
03/16/2012 Wood privacy fence completely obstructs access and visibility.	
mhashch_f_20130923_016.jpg

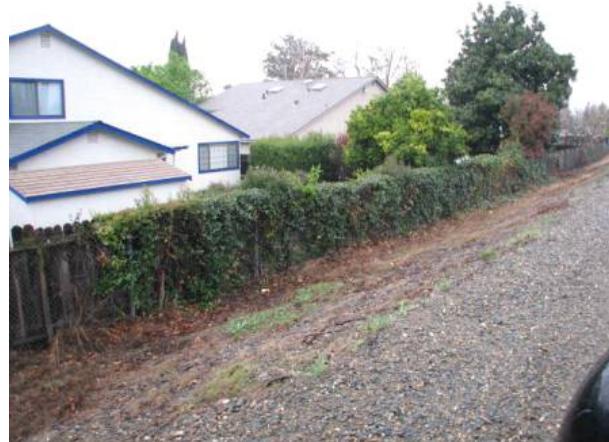
Levee Mile Report Line	222
Start Levee Mile	10.83
End Levee Mile	10.83
Location	Land Side
Category	Earthen Levee
Item	Encroachments
03/16/2012 Wood privacy fence completely obstructs access and visibility.	
mkhashch_f_20130923_024.jpg

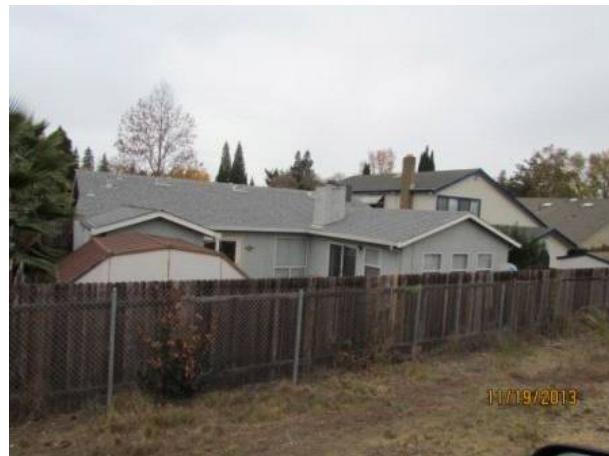
Levee Mile Report Line	223
Start Levee Mile	10.84
End Levee Mile	10.84
Location	Land Side
Category	Earthen Levee
Item	Encroachments
View of the fence obstructing visibility and access.	
mkhashch_f_20131120_720.JPG

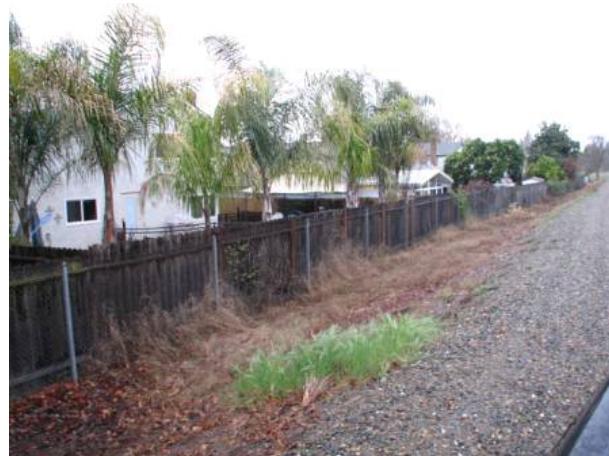
Levee Mile Report Line	224
Start Levee Mile	10.86
End Levee Mile	10.86
Location	Land Side
Category	Earthen Levee
Item	Encroachments
03/16/2012 Wood privacy fence completely obstructs access and visibility.	
mkhashch_f_20130923_018.jpg

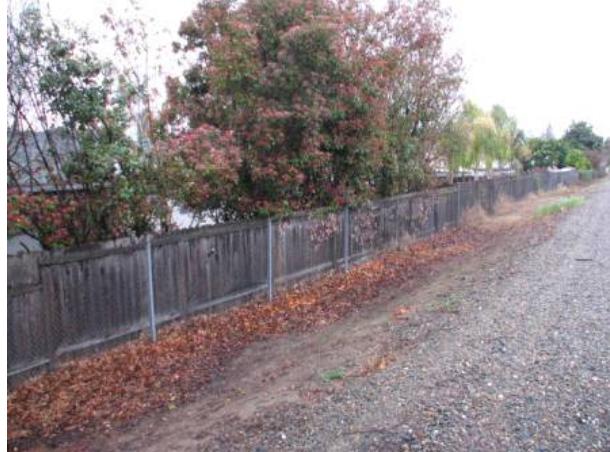
Levee Mile Report Line	225
Start Levee Mile	10.87
End Levee Mile	10.87
Location	Land Side
Category	Earthen Levee
Item	Encroachments
03/16/2012 Wood privacy fence completely obstructs access and visibility.	
mkhashch_f_20130923_023.jpg

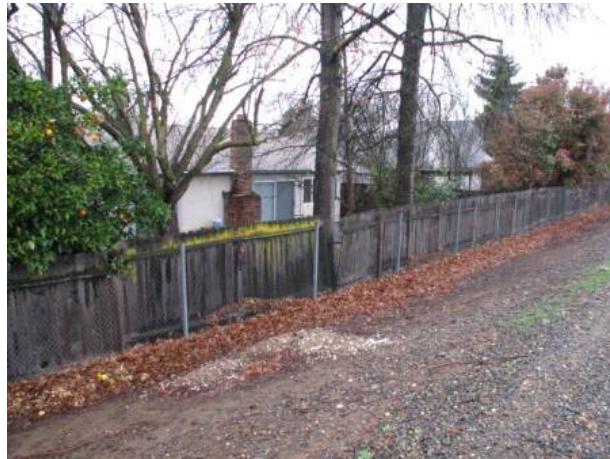
Levee Mile Report Line	226
Start Levee Mile	10.88
End Levee Mile	10.88
Location	Land Side
Category	Earthen Levee
Item	Vegetation
03/16/2012 Wood privacy fence completely obstructs access and visibility.	
mkhashch_f_20130923_021.jpg

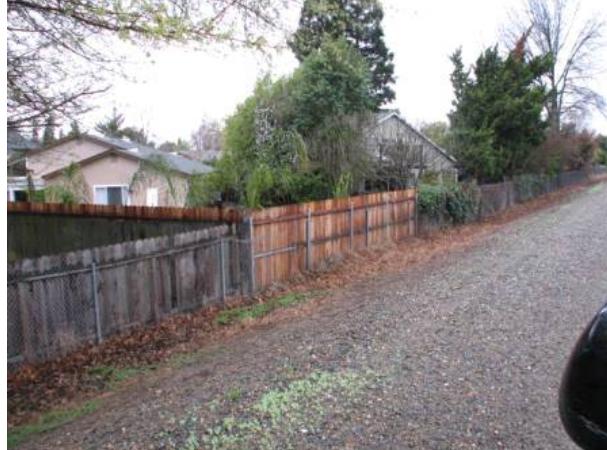
Levee Mile Report Line	228
Start Levee Mile	10.91
End Levee Mile	10.91
Location	Land Side
Category	Earthen Levee
Item	Encroachments
03/16/2012 Wood privacy fence completely obstructs access and visibility.	
mkhashch_f_20130923_017.jpg

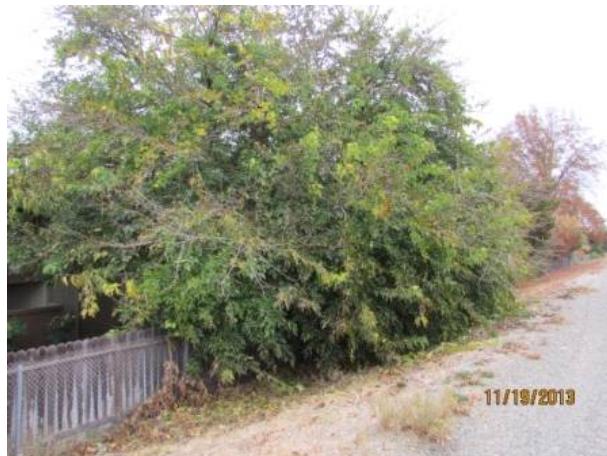
Levee Mile Report Line	229
Start Levee Mile	10.92
End Levee Mile	10.92
Location	Land Side
Category	Earthen Levee
Item	Trim / Thin Trees
View of the tree obstructing visibility of the landside levee slope.	
mkhashch_f_20131120_719.JPG

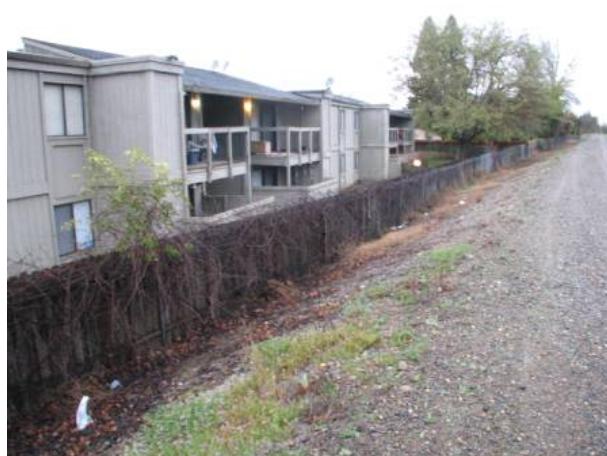
Levee Mile Report Line	230
Start Levee Mile	10.92
End Levee Mile	10.94
Location	Land Side
Category	Earthen Levee
Item	Encroachments
03/16/2012 Wood privacy fence completely obstructs access and visibility.	
mkhashch_f_20130923_020.jpg

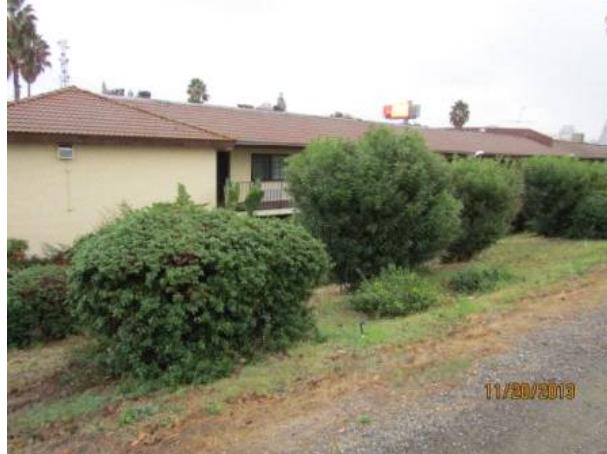
Levee Mile Report Line	1
Start Levee Mile	0.10
End Levee Mile	0.16
Location	Land Side
Category	Earthen Levee
Item	Vegetation
View of landscaping on landside levee slope obstructing visibility and access.	
mkhashch_f_20131120_737.JPG

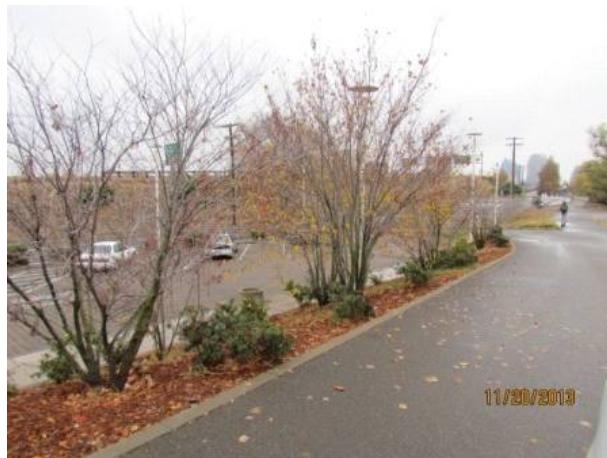
Levee Mile Report Line	2
Start Levee Mile	0.27
End Levee Mile	0.35
Location	Land Side
Category	Earthen Levee
Item	Vegetation
Landscaping at City intake facility.	
mkhashch_f_20131120_738.JPG

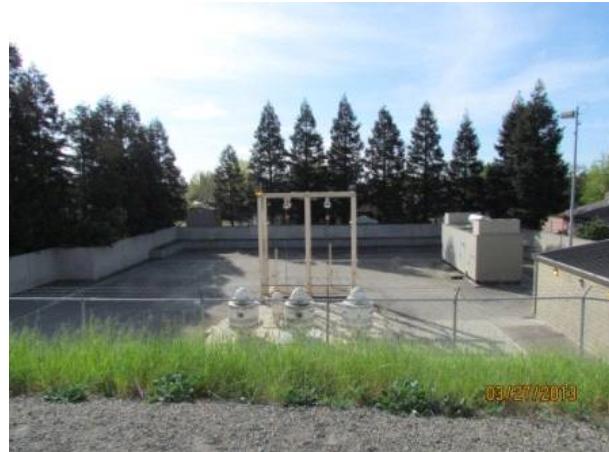
Levee Mile Report Line	1
Start Levee Mile	0.60
End Levee Mile	0.60
Location	Land Side
Category	Earthen Levee
Item	Encroachments
View of the pumping plant at the landside levee toe.	
mkhashch_f_20130923_068.JPG

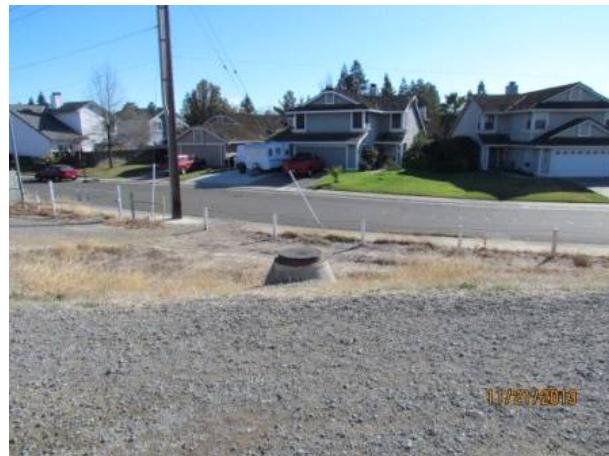
Levee Mile Report Line	2
Start Levee Mile	0.75
End Levee Mile	0.75
Location	Land Side
Category	Earthen Levee
Item	Encroachments
View of the pipe at the landside levee toe.	
mkhashch_f_20131121_746.JPG

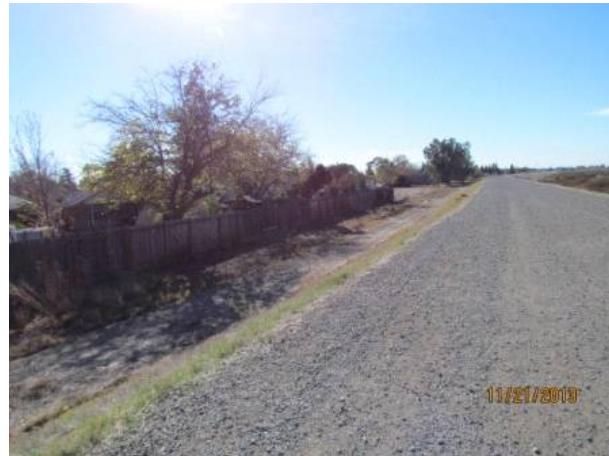
Levee Mile Report Line	3
Start Levee Mile	0.95
End Levee Mile	0.95
Location	Land Side
Category	Earthen Levee
Item	Vegetation
View of the acceptable vegetation control on the levee slope.	
mkhashch_f_20131121_745.JPG

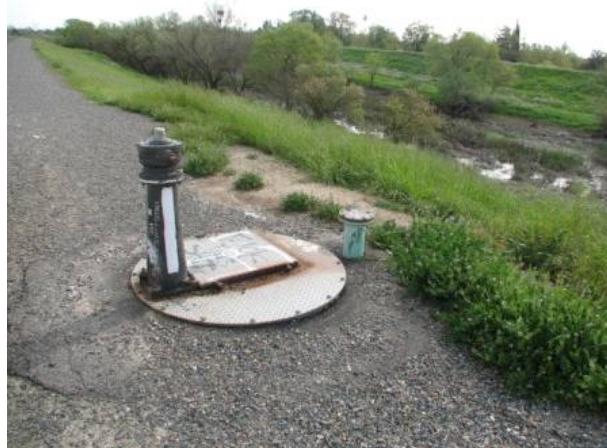
Levee Mile Report Line	1
Start Levee Mile	0.38
End Levee Mile	0.38
Location	Crown
Category	Earthen Levee
Item	Encroachments
Closure device for SS beneath channel.	
mkhashch_f_20130923_086.jpg

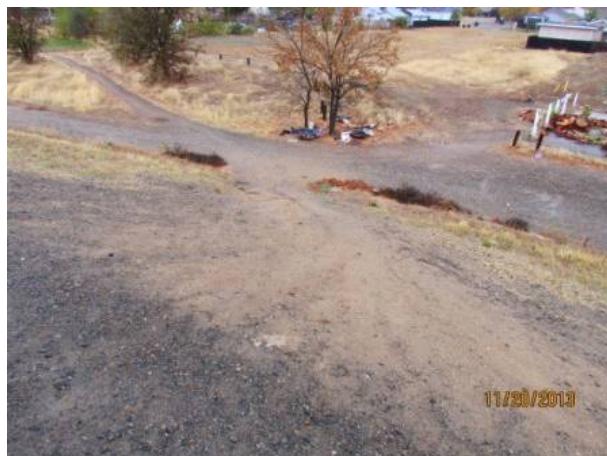
Levee Mile Report Line	2
Start Levee Mile	0.92
End Levee Mile	0.92
Location	Land Side
Category	Earthen Levee
Item	Slope Stability
View of the foot traffic on the landside levee slope.	
mkhashch_f_20131120_732.JPG

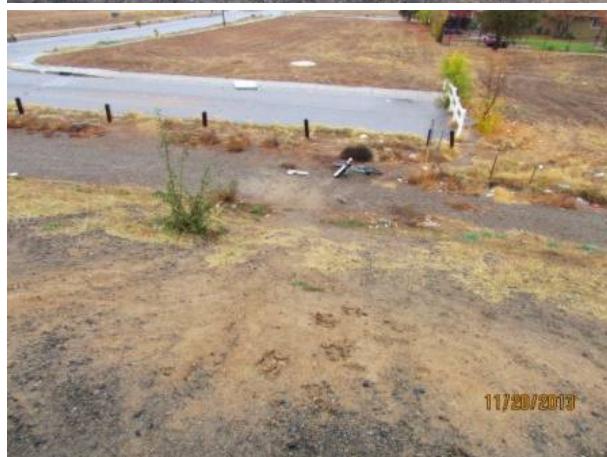
Levee Mile Report Line	3
Start Levee Mile	1.05
End Levee Mile	1.05
Location	Land Side
Category	Earthen Levee
Item	Slope Stability
View of the foot traffic on the landside levee toe.	
mkhashch_f_20131120_733.JPG

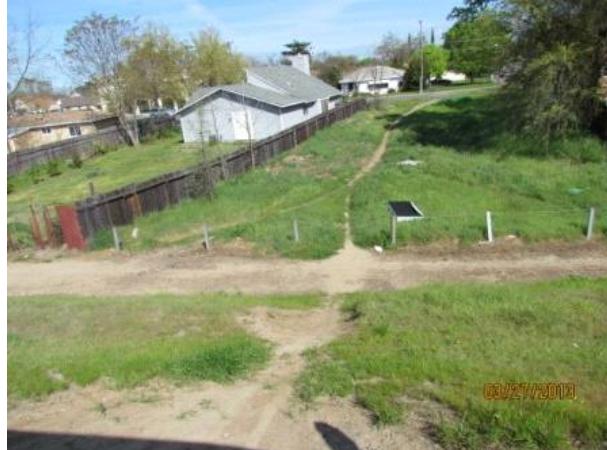
Levee Mile Report Line	4
Start Levee Mile	1.36
End Levee Mile	1.36
Location	Land Side
Category	Earthen Levee
Item	Slope Stability
View of the landside levee slope damaged by foot traffic.	
mkhashch_f_20130923_097.JPG

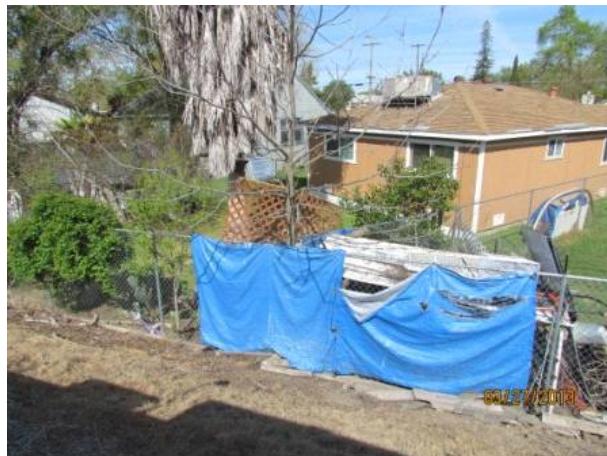
Levee Mile Report Line	5
Start Levee Mile	1.49
End Levee Mile	1.49
Location	Land Side
Category	Earthen Levee
Item	Encroachments
View of the fence obstruction visibility and access at the landside levee toe.	
mkhashch_f_20130923_075.JPG

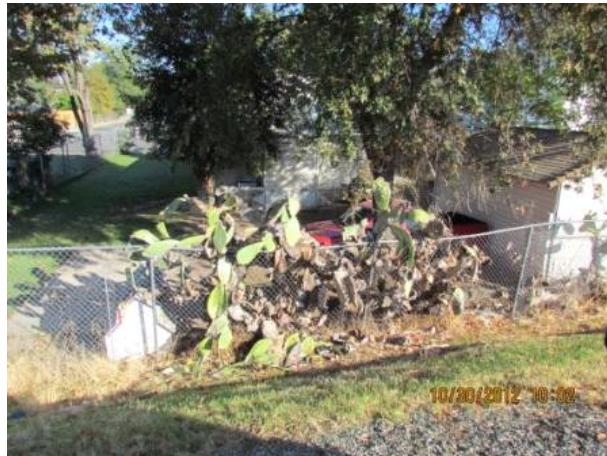
Levee Mile Report Line	6
Start Levee Mile	1.53
End Levee Mile	1.53
Location	Land Side
Category	Earthen Levee
Item	Vegetation
Large cactus is growing through the fence and obstructing access and visibility at the levee toe.	
mkhashch_f_20130923_070.JPG

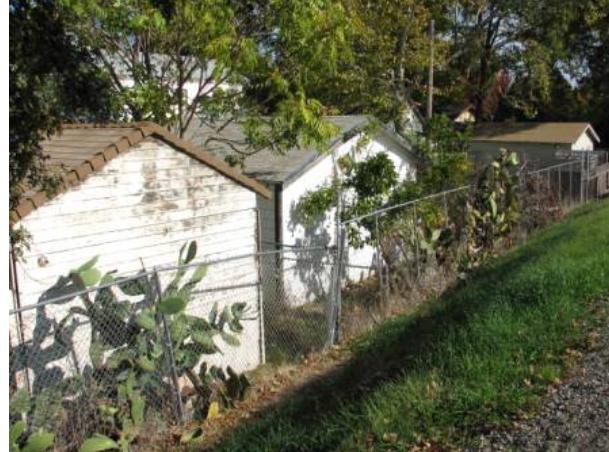
Levee Mile Report Line	7
Start Levee Mile	1.54
End Levee Mile	1.54
Location	Land Side
Category	Earthen Levee
Item	Encroachments
11/17/2011 Building obstructs visibility and access.	
mkhashch_f_20130923_096.jpg

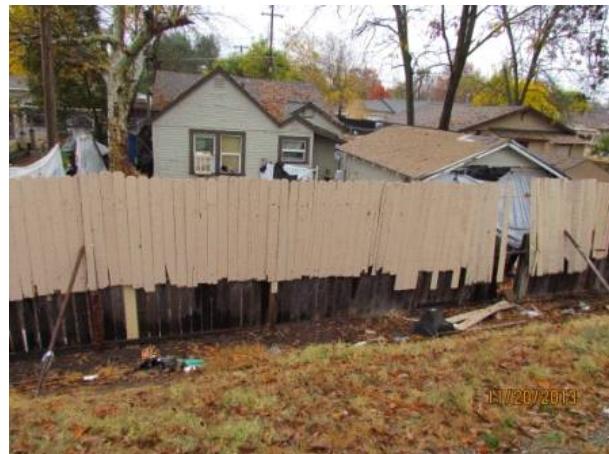
Levee Mile Report Line	8
Start Levee Mile	1.56
End Levee Mile	1.56
Location	Land Side
Category	Earthen Levee
Item	Encroachments
Wooden privacy fence is constructed at the landside levee toe.	
mkhashch_f_20131120_734.JPG

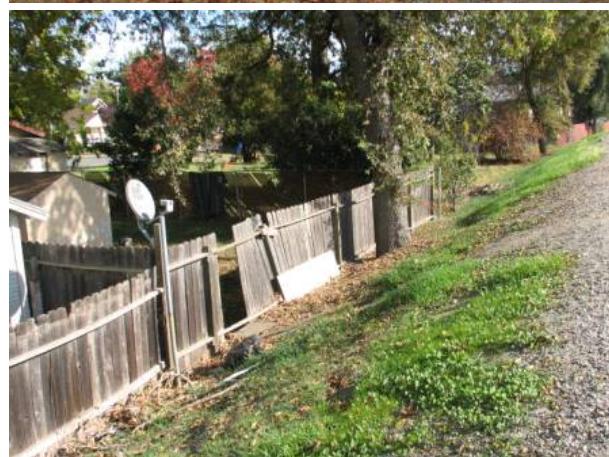
Levee Mile Report Line	9
Start Levee Mile	1.56
End Levee Mile	1.56
Location	Land Side
Category	Earthen Levee
Item	Encroachments
11/17/2011 Wooden privacy fence is constructed at the toe.	
mkhashch_f_20130923_072.jpg

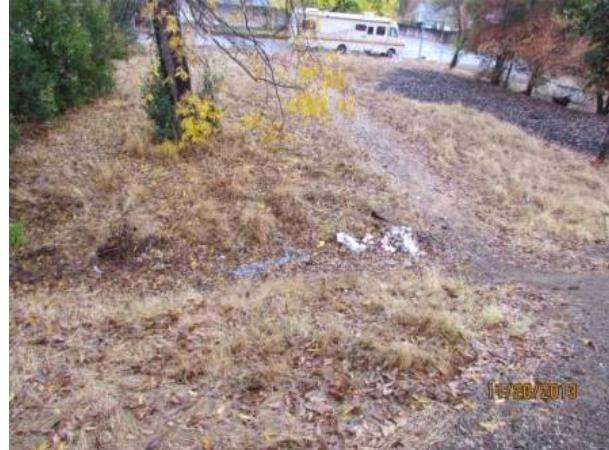
Levee Mile Report Line	10
Start Levee Mile	1.57
End Levee Mile	1.57
Location	Land Side
Category	Earthen Levee
Item	Encroachments
Yard waste and debris at the landside levee toe.	
mkhashch_f_20131120_735.JPG

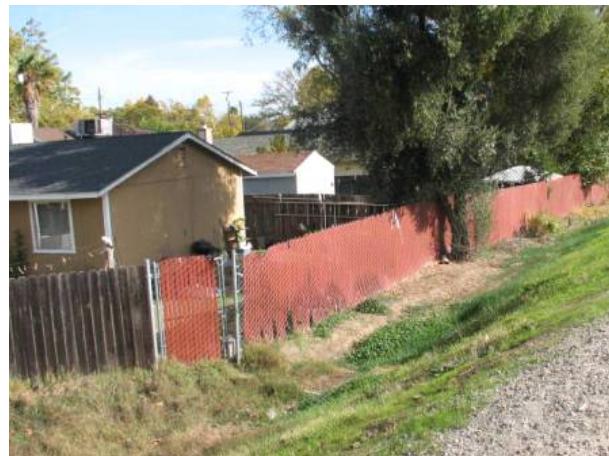
Levee Mile Report Line	11
Start Levee Mile	1.59
End Levee Mile	1.59
Location	Land Side
Category	Earthen Levee
Item	Encroachments
11/17/2011 Privacy fence is constructed at the toe.	
mkhashch_f_20130923_095.jpg

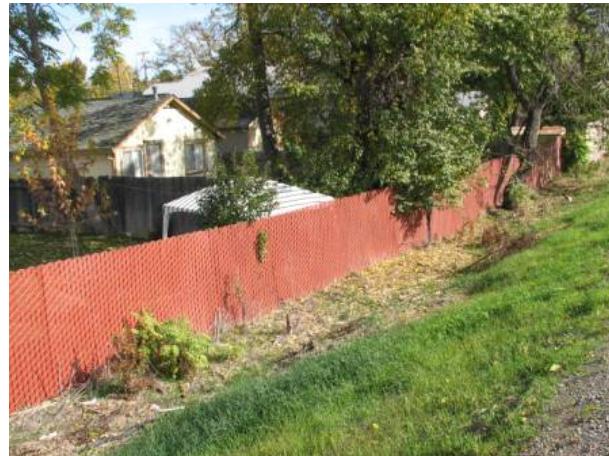
Levee Mile Report Line	12
Start Levee Mile	1.60
End Levee Mile	1.60
Location	Land Side
Category	Earthen Levee
Item	Encroachments
11/17/2011 Privacy fence is constructed at the toe.	
mkhashch_f_20130923_094.jpg

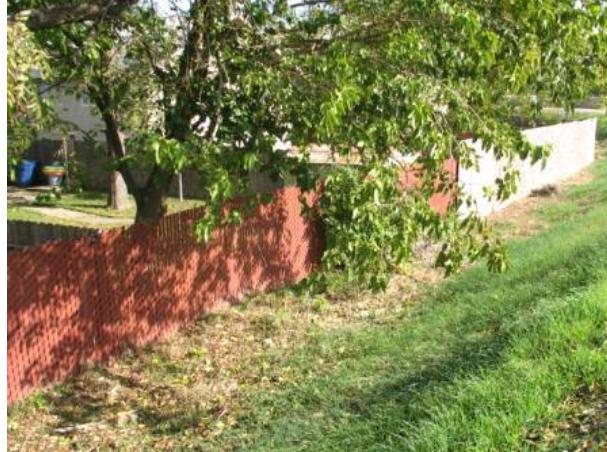
Levee Mile Report Line	13
Start Levee Mile	1.62
End Levee Mile	1.62
Location	Land Side
Category	Earthen Levee
Item	Encroachments
11/17/2011 Privacy fence is constructed at the toe.	
mkhashch_f_20130923_093.jpg

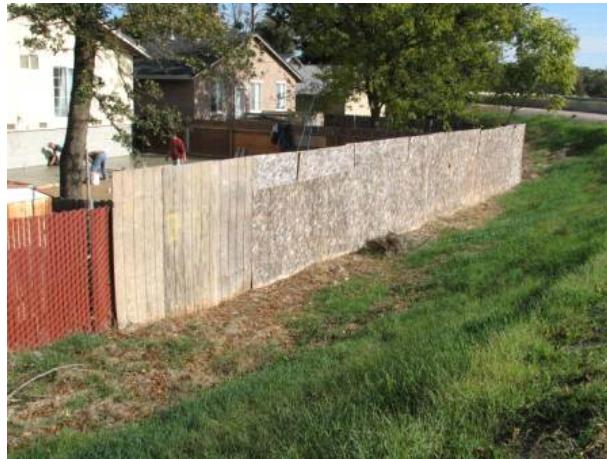
Levee Mile Report Line	14
Start Levee Mile	1.62
End Levee Mile	1.62
Location	Land Side
Category	Earthen Levee
Item	Encroachments
11/17/2011 Wooden privacy fence is constructed at the toe.	
mkhashch_f_20130923_092.jpg

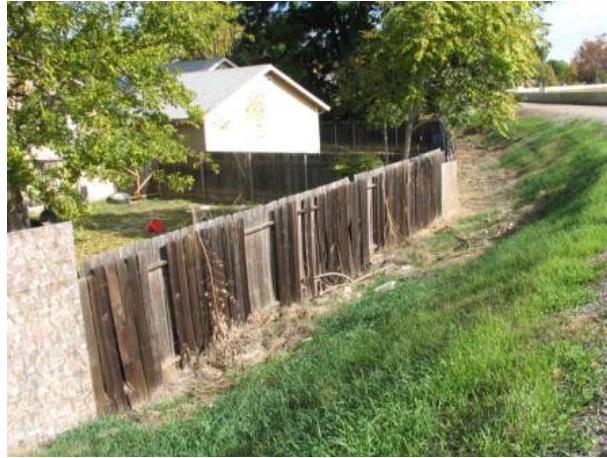
Levee Mile Report Line	17
Start Levee Mile	1.64
End Levee Mile	1.64
Location	Land Side
Category	Earthen Levee
Item	Encroachments
11/17/2011 Wooden privacy fence is constructed at the toe.	
mkhashch_f_20130923_091.jpg

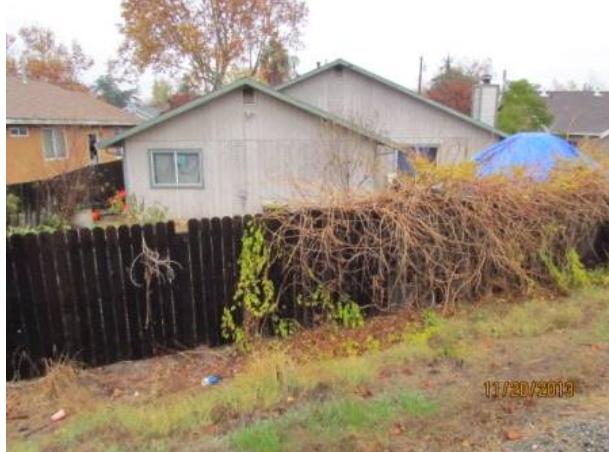
Levee Mile Report Line	18
Start Levee Mile	1.67
End Levee Mile	1.67
Location	Land Side
Category	Earthen Levee
Item	Encroachments
View of the wooden fence at the landside levee toe.	
mkhashch_f_20131120_736.JPG

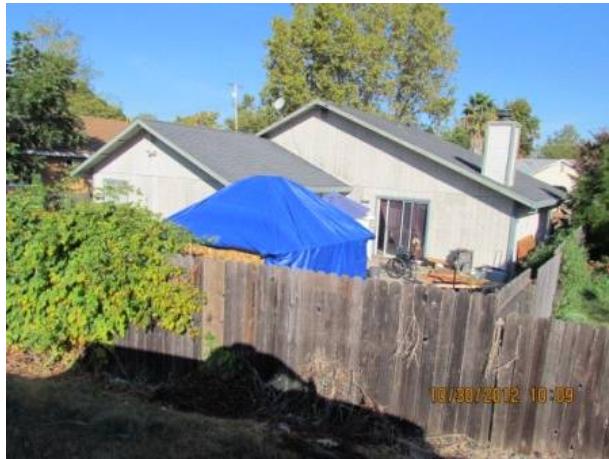
Levee Mile Report Line	19
Start Levee Mile	1.68
End Levee Mile	1.68
Location	Land Side
Category	Earthen Levee
Item	Encroachments
View of wood structure covered in tarp.	
mkhashch_f_20130923_069.JPG

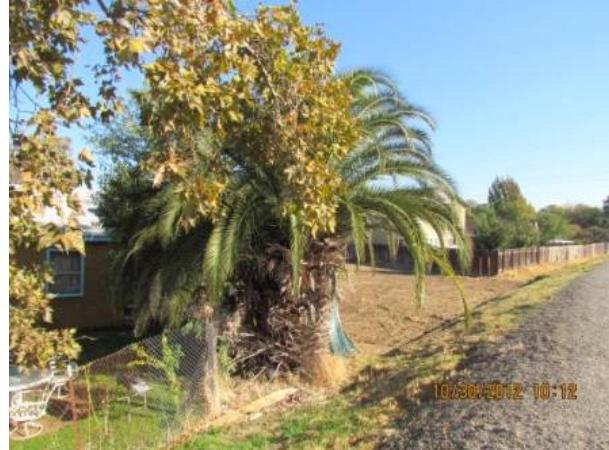
Levee Mile Report Line	21
Start Levee Mile	1.70
End Levee Mile	1.70
Location	Land Side
Category	Earthen Levee
Item	Vegetation
View of palm tree within 10-ft of the levee toe trimmed up from previous inspection.	
mkhashch_f_20130923_090.JPG

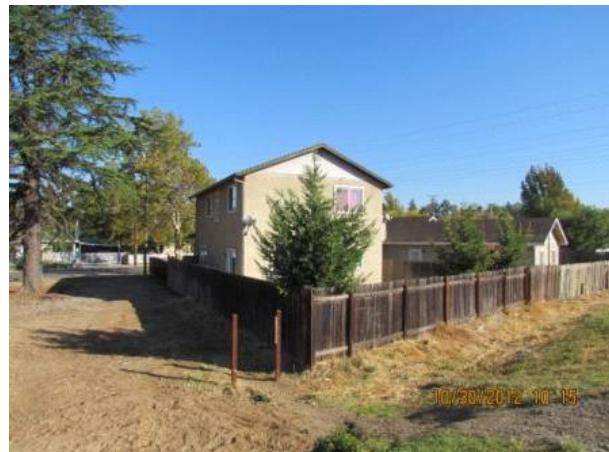
Levee Mile Report Line	22
Start Levee Mile	1.73
End Levee Mile	1.73
Location	Land Side
Category	Earthen Levee
Item	Encroachments
View of wooden privacy fence constructed at the toe.	
mkhashch_f_20130923_089.JPG

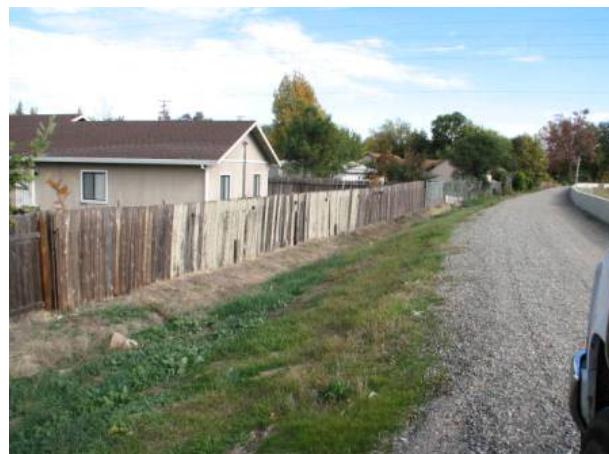
Levee Mile Report Line	23
Start Levee Mile	1.74
End Levee Mile	1.74
Location	Land Side
Category	Earthen Levee
Item	Encroachments
11/17/2011 Wooden privacy fence is constructed at the toe.	
mkhashch_f_20130923_076.jpg

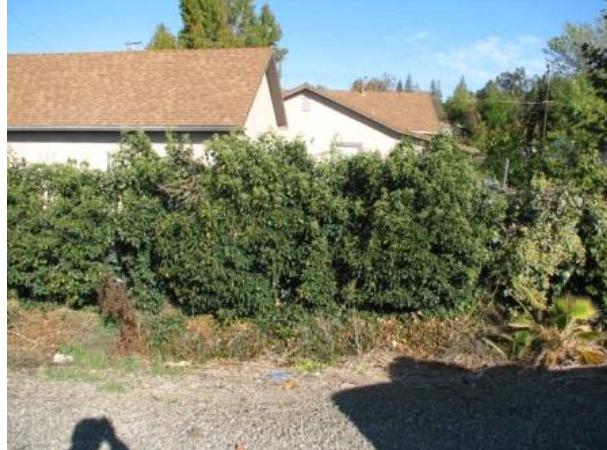
Levee Mile Report Line	24
Start Levee Mile	1.77
End Levee Mile	1.77
Location	Land Side
Category	Earthen Levee
Item	Vegetation
Fall 2009 photo of landscaping within 10-ft of the levee toe obstructs visibility and access.	
mkhashch_f_20130923_077.jpg

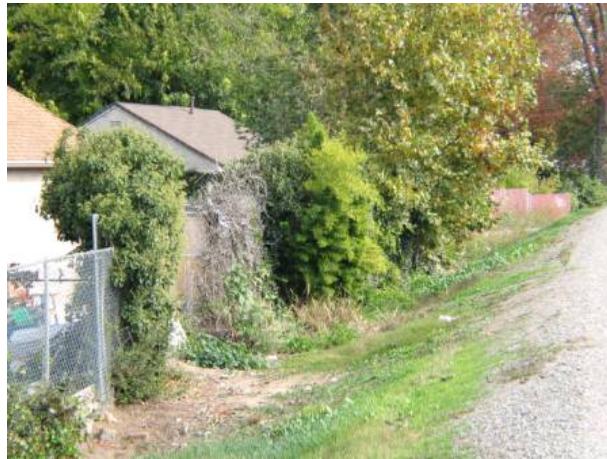
Levee Mile Report Line	24
Start Levee Mile	1.77
End Levee Mile	1.77
Location	Land Side
Category	Earthen Levee
Item	Vegetation
11/17/2011 Landscaping has grown over the fence and obstructs visibility and access.	
mkhashch_f_20130923_078.jpg

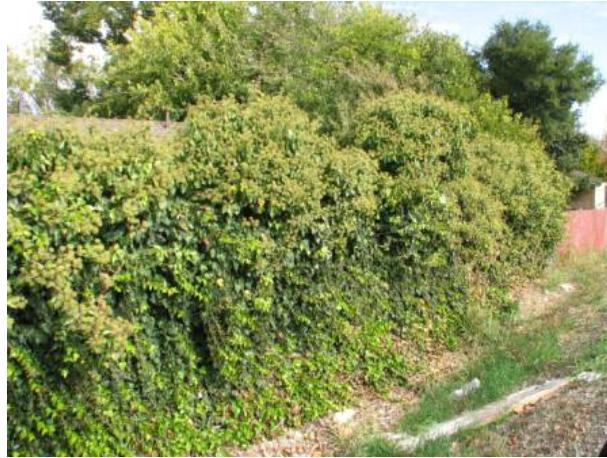
Levee Mile Report Line	25
Start Levee Mile	1.79
End Levee Mile	1.79
Location	Land Side
Category	Earthen Levee
Item	Vegetation
11/17/2011 Overgrown vegetation obstructs visibility and access.	
mkhashch_f_20130923_079.jpg

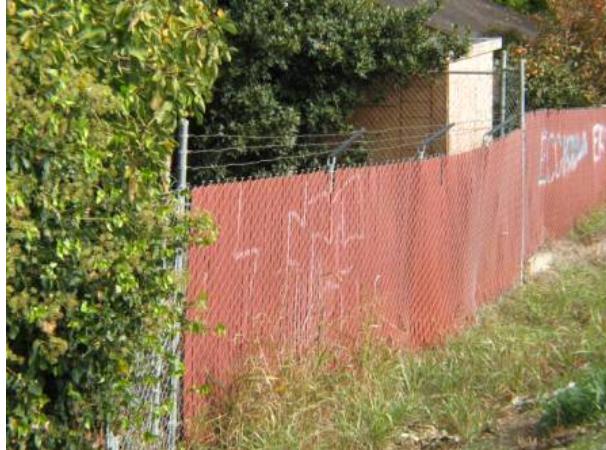
Levee Mile Report Line	26
Start Levee Mile	1.80
End Levee Mile	1.80
Location	Land Side
Category	Earthen Levee
Item	Encroachments
11/17/2011 Barbed wire topped privacy fence is located at the toe.	
mkhashch_f_20130923_080.jpg

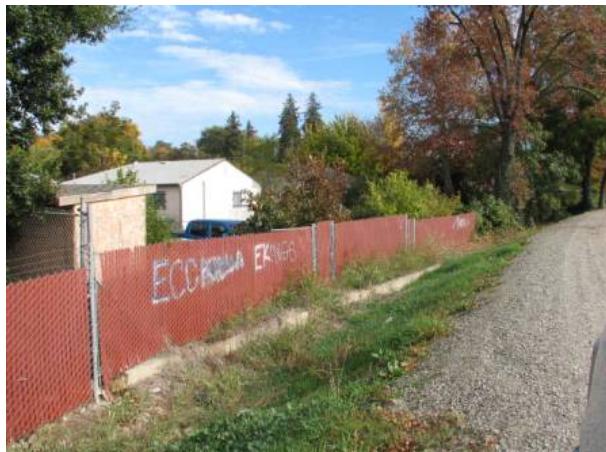
Levee Mile Report Line	27
Start Levee Mile	1.81
End Levee Mile	1.81
Location	Land Side
Category	Earthen Levee
Item	Encroachments
11/17/2011 Privacy fence is located at the toe.	
mkhashch_f_20130923_081.jpg

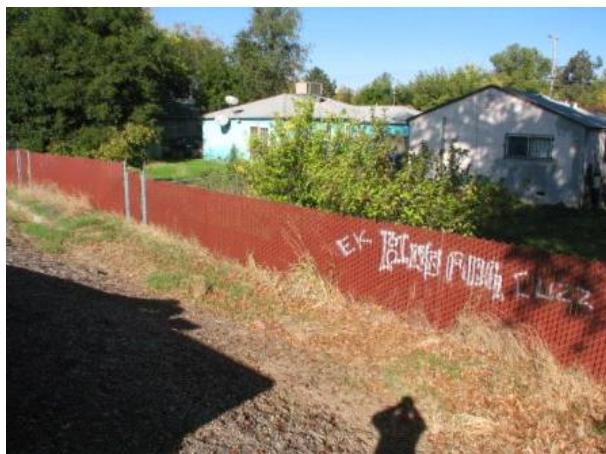
Levee Mile Report Line	28
Start Levee Mile	1.81
End Levee Mile	1.81
Location	Land Side
Category	Earthen Levee
Item	Encroachments
Fall 2009 photo of privacy fence within 10-ft of the levee toe obstructs visibility and access.	
mkhashch_f_20130923_082.jpg

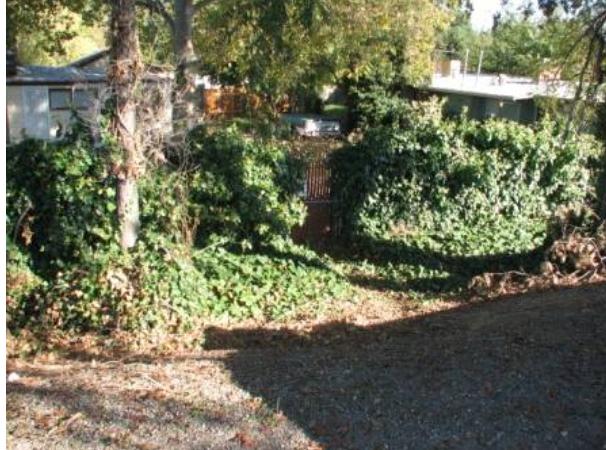
Levee Mile Report Line	29
Start Levee Mile	1.83
End Levee Mile	1.83
Location	Land Side
Category	Earthen Levee
Item	Vegetation
Fall 2009 photo of dense ivy and fence obstruct visibility and access.	
mkhashch_f_20130923_083.jpg

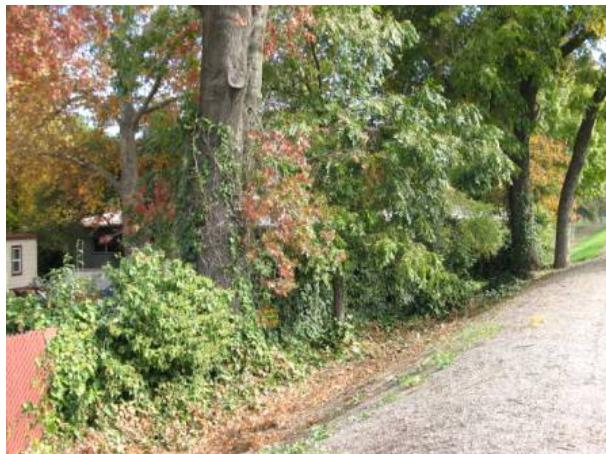
Levee Mile Report Line	29
Start Levee Mile	1.83
End Levee Mile	1.83
Location	Land Side
Category	Earthen Levee
Item	Vegetation
11/17/2011 Dense vegetation at the toe.	
mkhashch_f_20130923_084.jpg

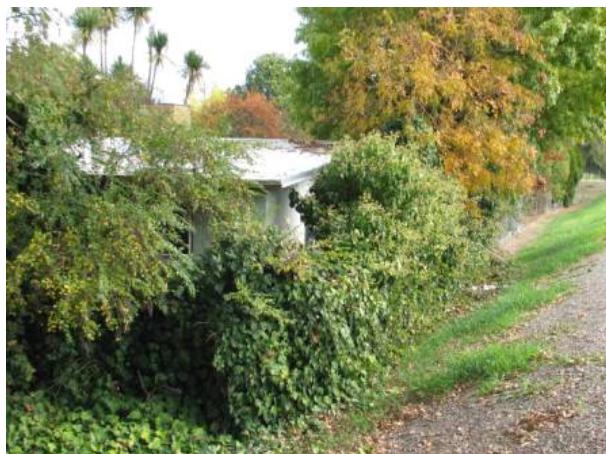
Levee Mile Report Line	30
Start Levee Mile	1.84
End Levee Mile	1.84
Location	Land Side
Category	Earthen Levee
Item	Vegetation
11/17/2011 Vegetation and building obstruct visibility and access to the levee toe.	
mkhashch_f_20130923_085.jpg

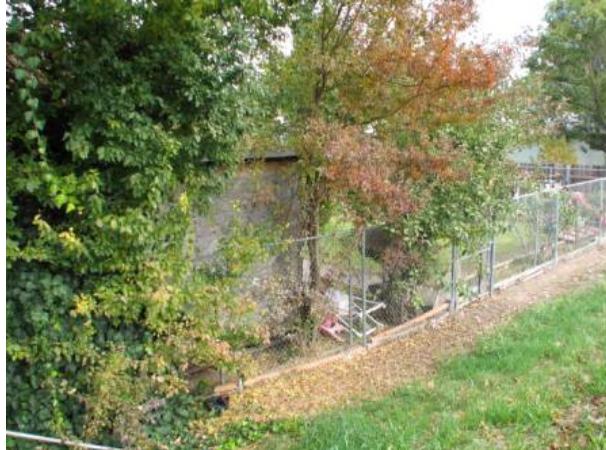
Levee Mile Report Line	31
Start Levee Mile	1.85
End Levee Mile	1.85
Location	Land Side
Category	Earthen Levee
Item	Encroachments
11/17/2011 Building is too close to the levee toe and obstructs visibility and access.	
mkhashch_f_20130923_088.jpg

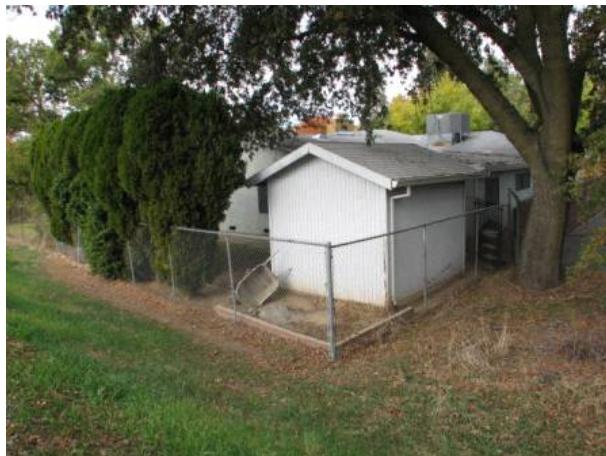
Levee Mile Report Line	32
Start Levee Mile	1.88
End Levee Mile	1.88
Location	Land Side
Category	Earthen Levee
Item	Vegetation
11/17/2011 Building and landscaping are too close to the levee toe.	
mkhashch_f_20130923_087.jpg

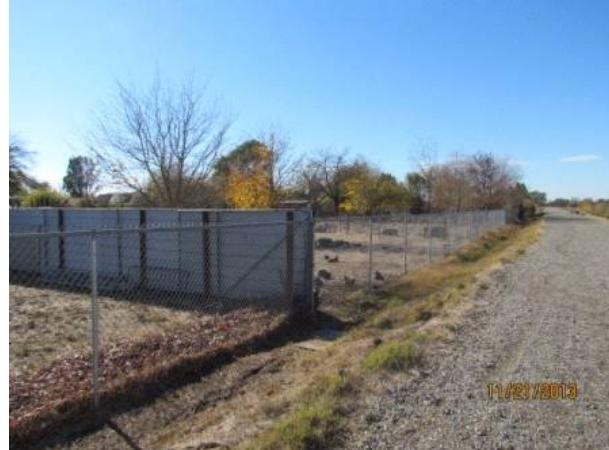
Levee Mile Report Line	1
Start Levee Mile	0.31
End Levee Mile	0.48
Location	Land Side
Category	Earthen Levee
Item	Encroachments
View of the chainlink fence at landside levee toe facing downstream.	
mhashch_f_20131121_742.JPG

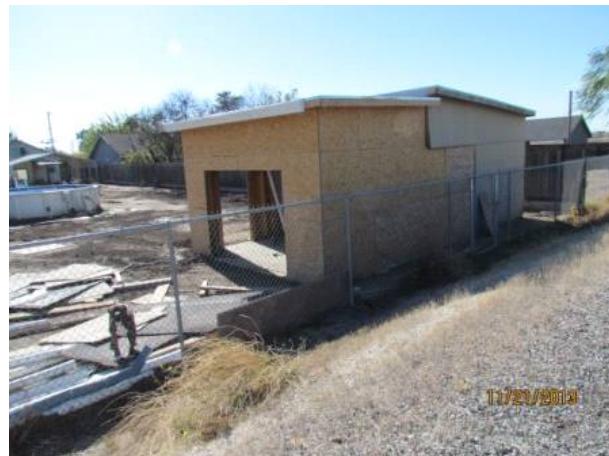
Levee Mile Report Line	3
Start Levee Mile	0.33
End Levee Mile	0.33
Location	Land Side
Category	Earthen Levee
Item	Encroachments
View of the building under long term construction or remodel within 10 feet of landside levee toe, facing downstream.	
mhashch_f_20131121_743.JPG

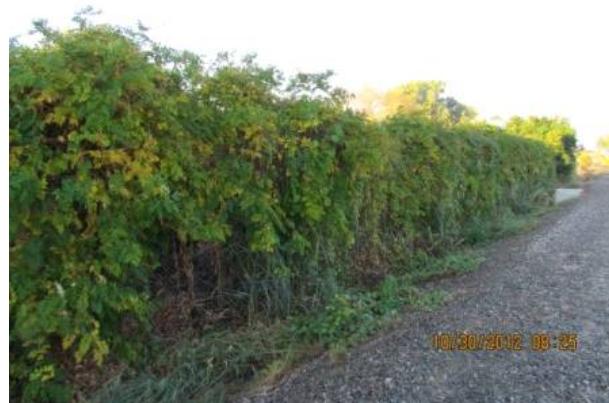
Levee Mile Report Line	4
Start Levee Mile	0.43
End Levee Mile	0.43
Location	Land Side
Category	Earthen Levee
Item	Vegetation
View of the vines on fence obstructing visibility of landside toe.	
mhashch_f_20130923_103.JPG

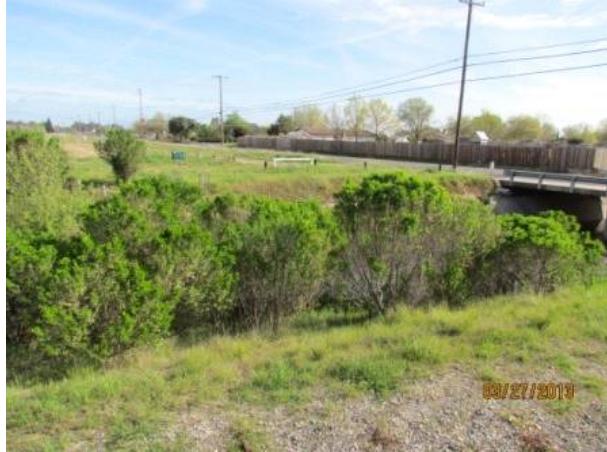
Levee Mile Report Line	5
Start Levee Mile	0.48
End Levee Mile	0.48
Location	Water Side
Category	Earthen Levee
Item	Vegetation
View of the woody vegetation on the waterside levee slope.	
mhashch_f_20130923_107.JPG

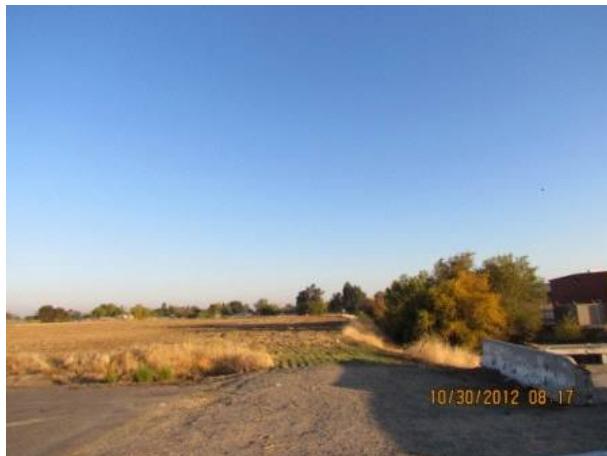
Levee Mile Report Line	6
Start Levee Mile	0.51
End Levee Mile	1.02
Location	Water Side
Category	Earthen Levee
Item	Encroachments
View from downstream end of inaccessible portion of Magpie Creek due to landowner restrictions. There is no levee for ARFC to maintain at this location. However, the channel maintenance is the responsibility of Sacramento Yard.	
mhashch_f_20130923_100.JPG

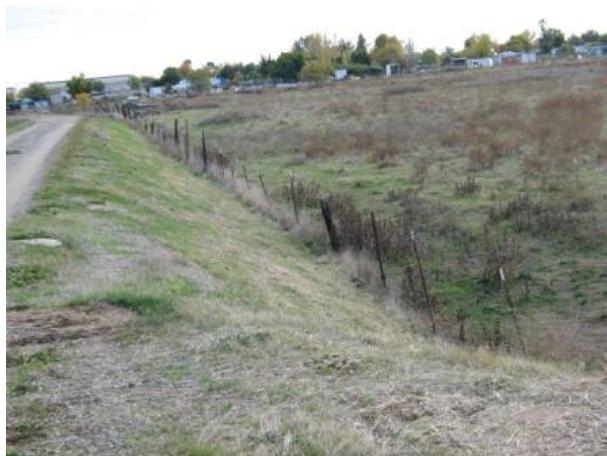
Levee Mile Report Line	7
Start Levee Mile	1.22
End Levee Mile	1.28
Location	Land Side
Category	Earthen Levee
Item	Encroachments
11/17/2011 Barbed wire fence at levee toe.	
mhashch_f_20130923_101.jpg

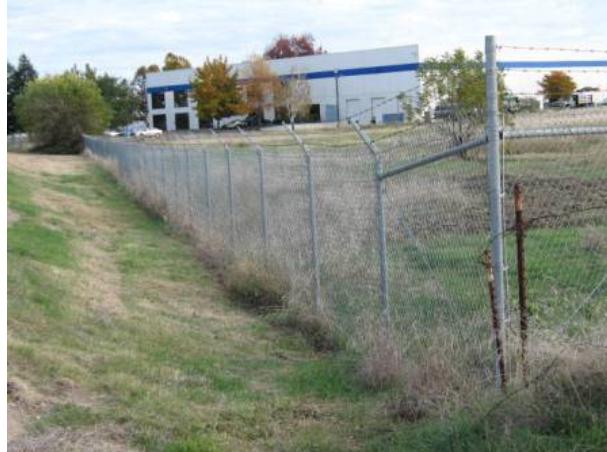
Levee Mile Report Line	8
Start Levee Mile	1.29
End Levee Mile	1.32
Location	Land Side
Category	Earthen Levee
Item	Encroachments
11/17/2011 Chainlink fence at levee toe.	
mhashch_f_20130923_104.jpg

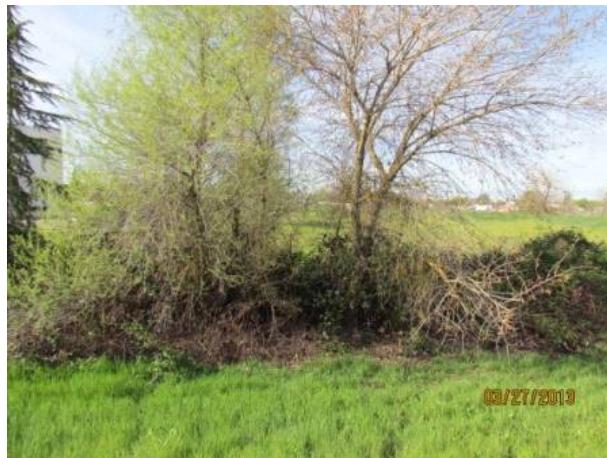
Levee Mile Report Line	9
Start Levee Mile	1.38
End Levee Mile	1.38
Location	Land Side
Category	Earthen Levee
Item	Vegetation
View of the woody vegetation to be removed from the landside levee toe.	
mhashch_f_20130923_106.JPG

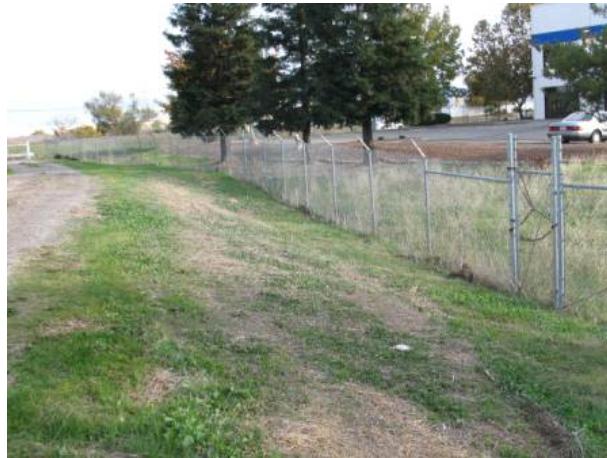
Levee Mile Report Line	10
Start Levee Mile	1.38
End Levee Mile	1.42
Location	Land Side
Category	Earthen Levee
Item	Encroachments
11/17/2011 Chainlink fence alignment returns to the levee toe.	
mhashch_f_20130923_105.jpg

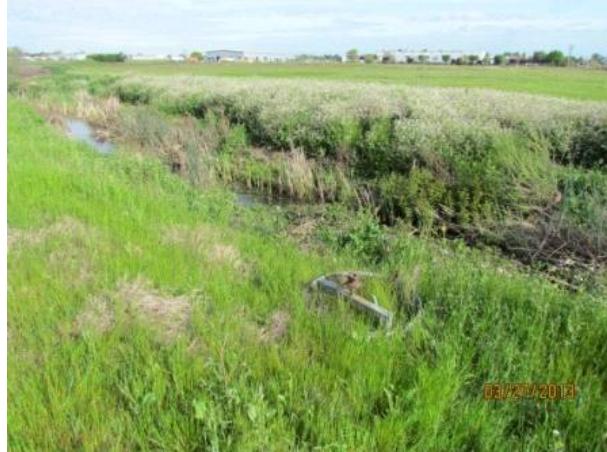
Levee Mile Report Line	11
Start Levee Mile	1.39
End Levee Mile	1.39
Location	Water Side
Category	Earthen Levee
Item	Encroachments
View of the gate valve at the waterside levee hinge.	
mkhashch_f_20130923_102.JPG
